EPA Region IX and California Water Resources Control Board

Sanitary Sewer Collection System Inspection Report

Collection System Name and Location City of Rancho Palos Verdes Collection System 30490 Hawthorne Blvd. Rancho Palos Verdes, CA 90275		Entry Date 8/10/2012 Entry Time 8:00 AM	Permit Effective Date 5/2/2006								
Order Number 2006-0003-DWQ & 2008-0002-EXEC	WDID Number 4SSO10420		Permit Expiration Date								
Name(s) & Title(s) of On-Site Representative(s) Ron Dragoo (Senior Engineer - RPV) Robert Swartz (Senior Civil Engineer - LA County DPW) Emilio Blanco (Maintenance Superintendent - RPV)	Contact Information Phone: (310) 544-5250 E-mail: rond@rpv.com	Notified of Inspection? <input checked="" type="checkbox"/> Yes <input type="checkbox"/> No									
Name, Title & Address of Responsible Official Ron Dragoo (Senior Engineer) 30490 Hawthorne Blvd. Rancho Palos Verdes, CA 90275	Contact Information Phone: (310) 544-5250 E-mail: rond@rpv.com	Official Contacted? <input checked="" type="checkbox"/> Yes <input type="checkbox"/> No									
Inspector(s) Primary: Jake Albright (PG Environmental, LLC) Other(s): Barbara Guia (Los Angeles Water Board); and Andrew Choi (Los Angeles

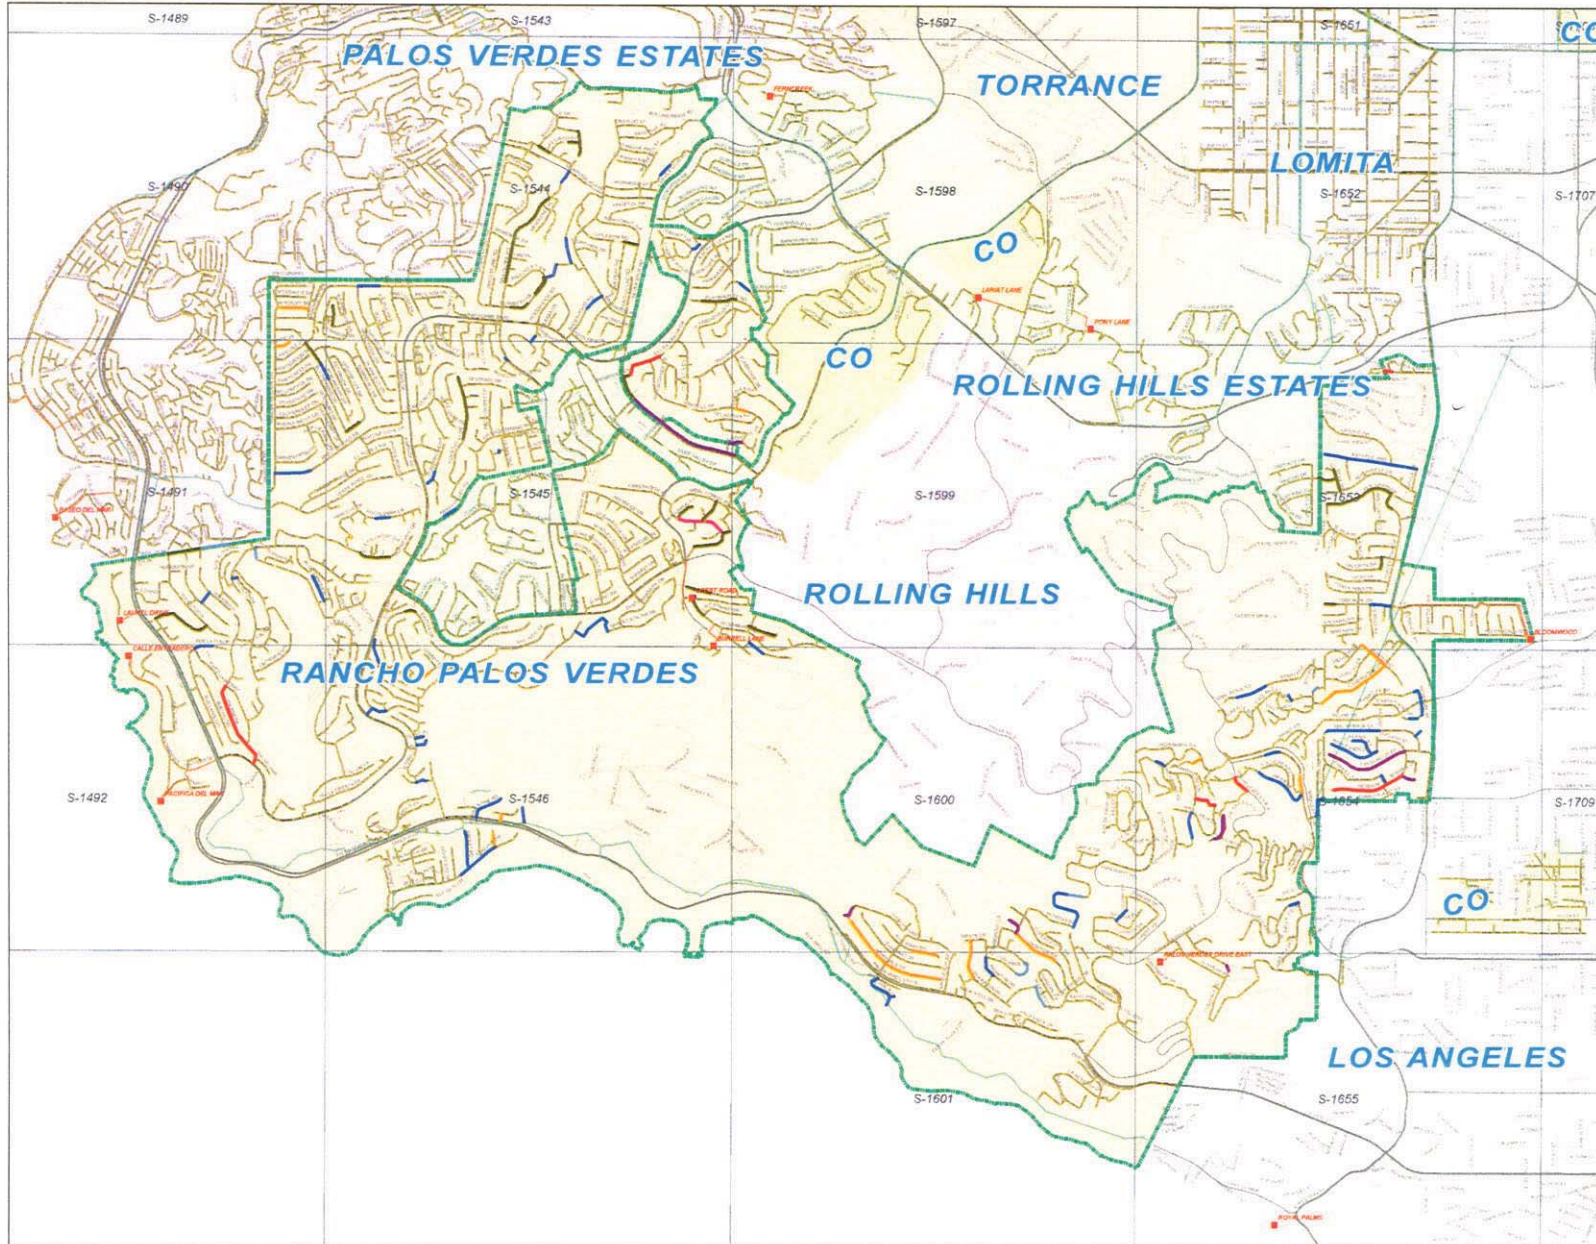
Attachment 5

DPW Maintenance Map for Rancho Palos Verdes

MAINTENANCE MAP PERIODICS **CITY OF** **RANCHO PALOS VERDES** SUPERVISORIAL DISTRICT 4
